# K750 INSULATED ENERGY DOOR

Designed specifically for temperature controlled areas, Energy door/strip combines exceptional thermal efficiency with flexibility. It also delivers a host of performance and safety benefits in a wide variety of applications.

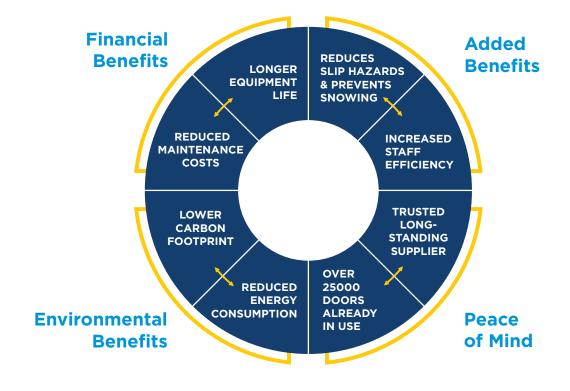
There are two layers of insulation with an air gap in between, which places it in a different league when it comes to keeping cool air in and warm air out.

High Visibility Flexible Panels Lightweight

Resistant

Panels

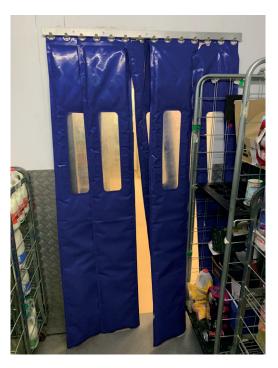
5. Strips becoming misshaped

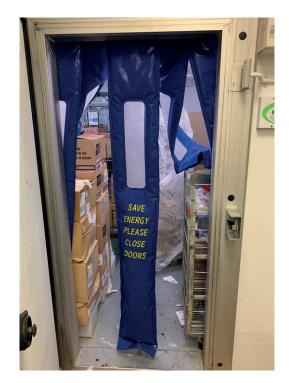
2. Gaps in strip curtains

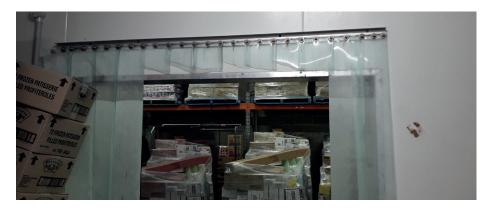
8 & 9. Strips hooked out of the way by staff leaving no thermal barrier
